Name of Dam: Whites Dam

Location: Albemarle County, State of Virginia

Inventory Number: VA 00327

PHASE I INSPECTION REPORT NATIONAL DAM SAFETY PROGRAM

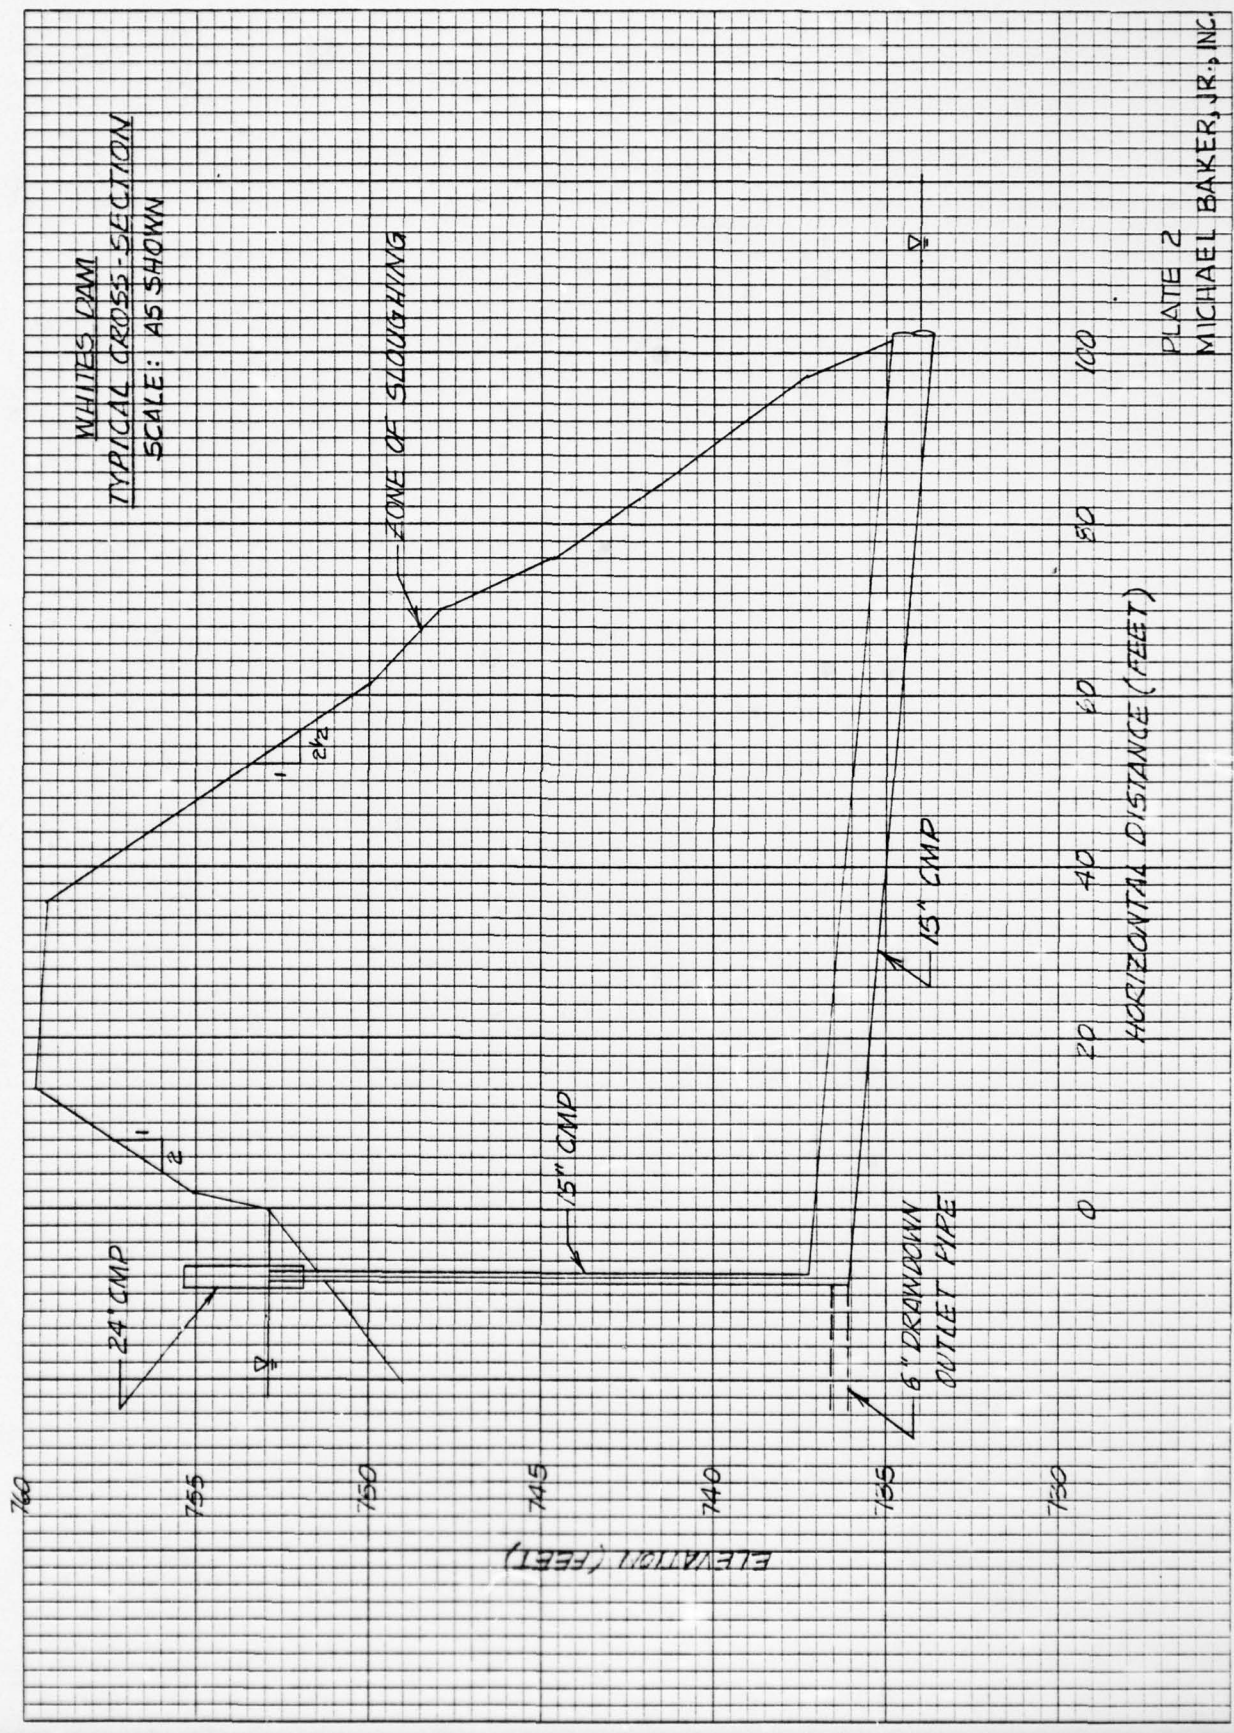
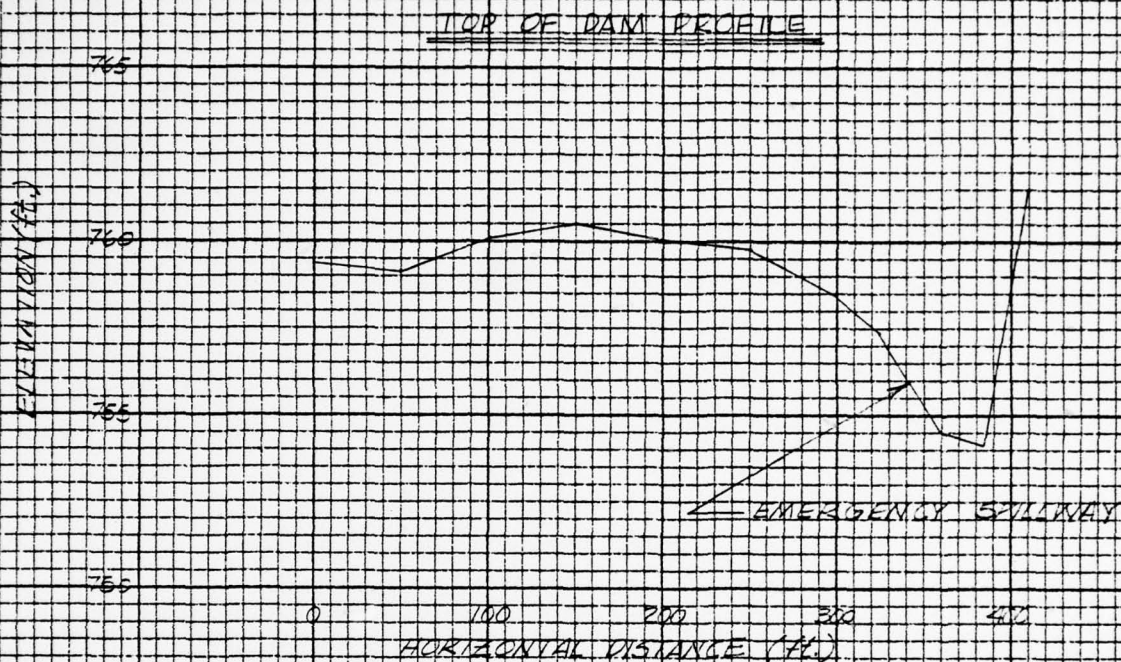
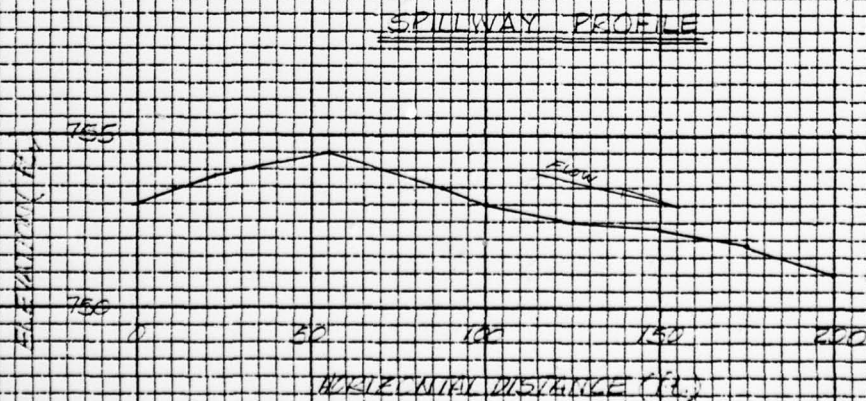
PLATE 3
WHITES DAM
TOP OF DAM AND SPILLWAY
PROFILE
MICHAEL BAKER, JR., INC.
SCALE: AS SHOWN

- 4.1 Procedures: Operation of the dam is automatic. Normal pool (elevation 753.0 feet M.S.L.) is maintained by the vertically standing 15 inch diameter corrugated metal pipe (see Photo 1 and Plate 3). In the event that the reservoir level rises above elevation 754.3 feet M.S.L., water will also flow past the dam through the emergency spillway located outside the right abutment.
